Safety Alert

Mines Inspectorate

Safety Alert Issue No.: CIM/02/2024

HPI – Mine Light Vehicle Overturn Incident

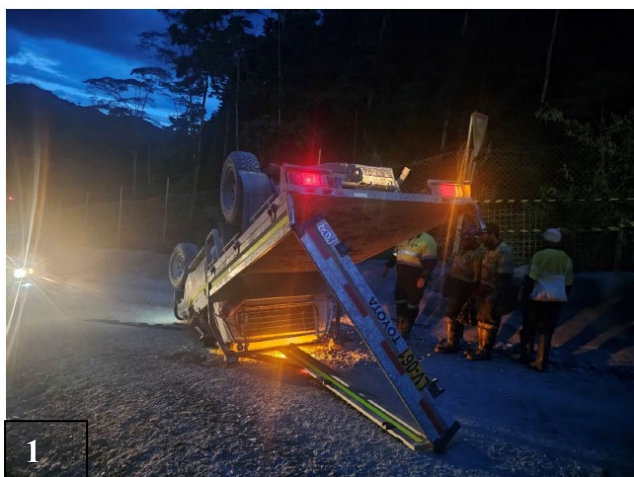
Photo 1: Back view of light vehicle (ute)

- The driver violated the existing traffic management plan.
- The driver's focus was distracted, hence, he (driver) had high risk driving behavior.
- Mechanical failure of LV braking system (lack of proper maintenance system).
- Inadequate traffic management system.
- Non-compliance to mine site radio communication process whilst driving.
- Driver failure to drive to road condition.
- Driver's lack of competency for safe driving.
- LV travelling at higher speed.

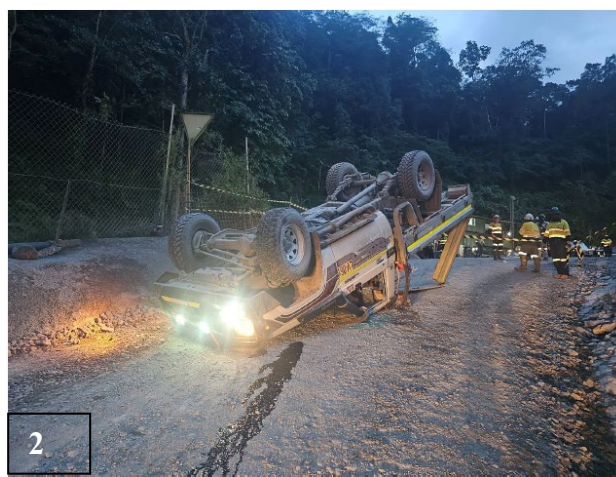
Photo 2: Fronth view of light vehicle (ute)
