SAFETY ALERT

Safety Alert Issue No: CIM/006/2024

Date: 15th April 2024

High Potential Accident -Broken Bolts of a Ball Mill Shell Flange.

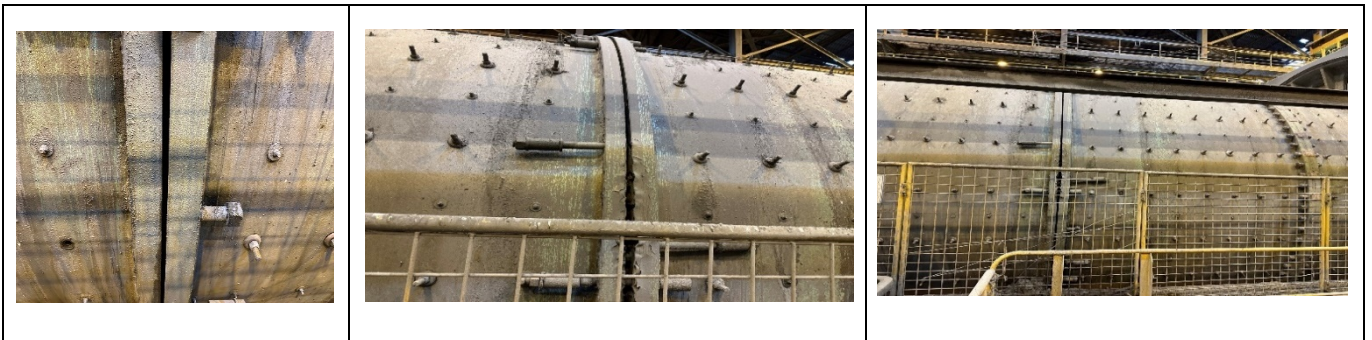
On Tuesday, 9th April 2024, during night shift, a ball mill at a grinding circuit encountered excessive slurry spillage from the shell flange at the discharge end of the mill. This was identified by process plant operators, and they immediately stopped the ball mill safely. Upon inspection, approximately 50% of the shell flange bolts were either broken and/or cracked. The gap between the shell flange had opened to about 30mm.

- Incompetent; process plant operators, maintenance personnel and supervisors
- Lack of proper and regular inspection of the ball mill flange bolts,
- Failure to properly torque the flange bolts at the time of installation of the ball mill shell.
- Failure to retorque the flange bolts over an operating period,
- Improper or incorrect application of the bolt grade or class for the ball mill shell flange.
- Lack of proper maintenance system of the ball mill shell flange bolts
- Ball mill shell flange bolts were overdue for changeout.
- Improper operation of the ball mill

- Reassess the competency of process plant operators, maintenance personnel and supervisors.
- Develop and implement proper inspection and testing schedules of the ball mill shell flange bolts.
- Ensure competent maintenance personnel torque and retorques the flange bolts, including other mills.
- Remove and replace all components including the ball mill shell flange bolts that have exceeded their life cycle.
- Ensure all mills are being operated in compliance with the design specifications.
