# Safety Alert

Safety Alert Issue No: CIM/005/2024

## Serious Accident – Vehicle Collision

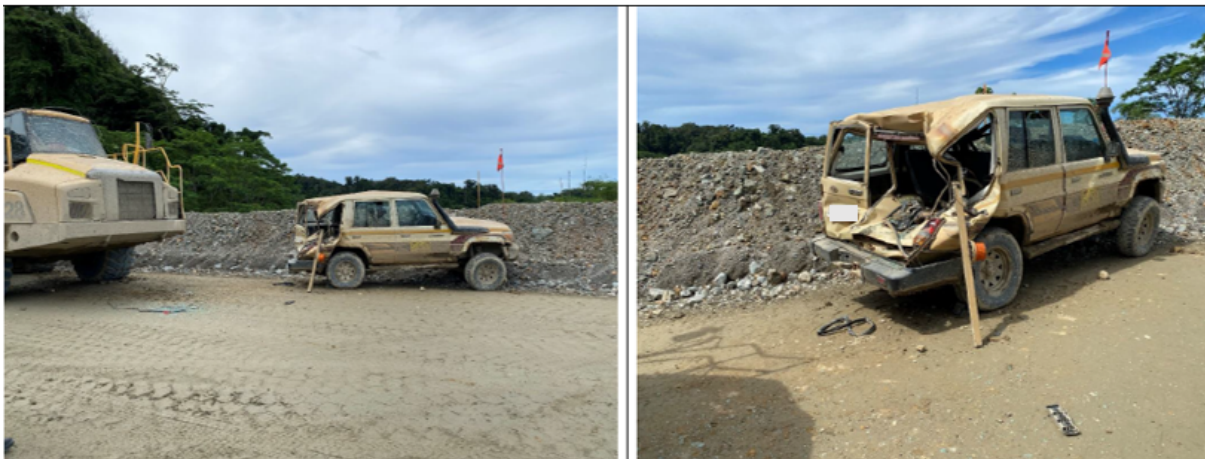
A serious accident had occurred within a mining operational site when an articulated haul truck (AHT) collided into a moving light vehicle (LV). The AHT was enroute to its destination for the first load after lunch break. While travelling the AHT collided with the rear end of a moving LV, which was also travelling ahead of the AHT in the same direction.

The LV had two persons at the time of the accident the driver of the LV and an operator. As a result of the collision, both persons of the LV sustained serious bodily injuries. One person showed signs indicative of a possible left shoulder fracture, while the other exhibited potential signs of a C-Spinal Fracture.

- Haul truck driver error, fatigue and distraction.
- Operator and driver incompetency.
- Not driving to road conditions.
- Inadequate separation distance between the AHT and LV (Safe Driving Distance NOT Observed by AHT Operator).
- No proximity detection and collision avoidance technology.
- Haul truck poor equipment maintenance.
- Lack of proper traffic management systems.
